HO-150  
The Lorenz House  
Elkridge  
Private

circa 1832

INVENTORY FORM FOR STATE HISTORIC SITES SURVEY

The Lorenz House

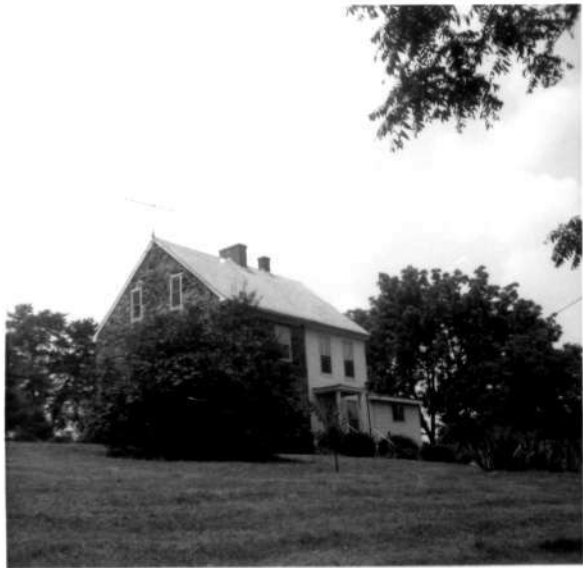
Lorenz house JSC 6/72

2-story -  $\frac{1}{2}$  stone +  $\frac{1}{2}$  frame - good  
Condition —

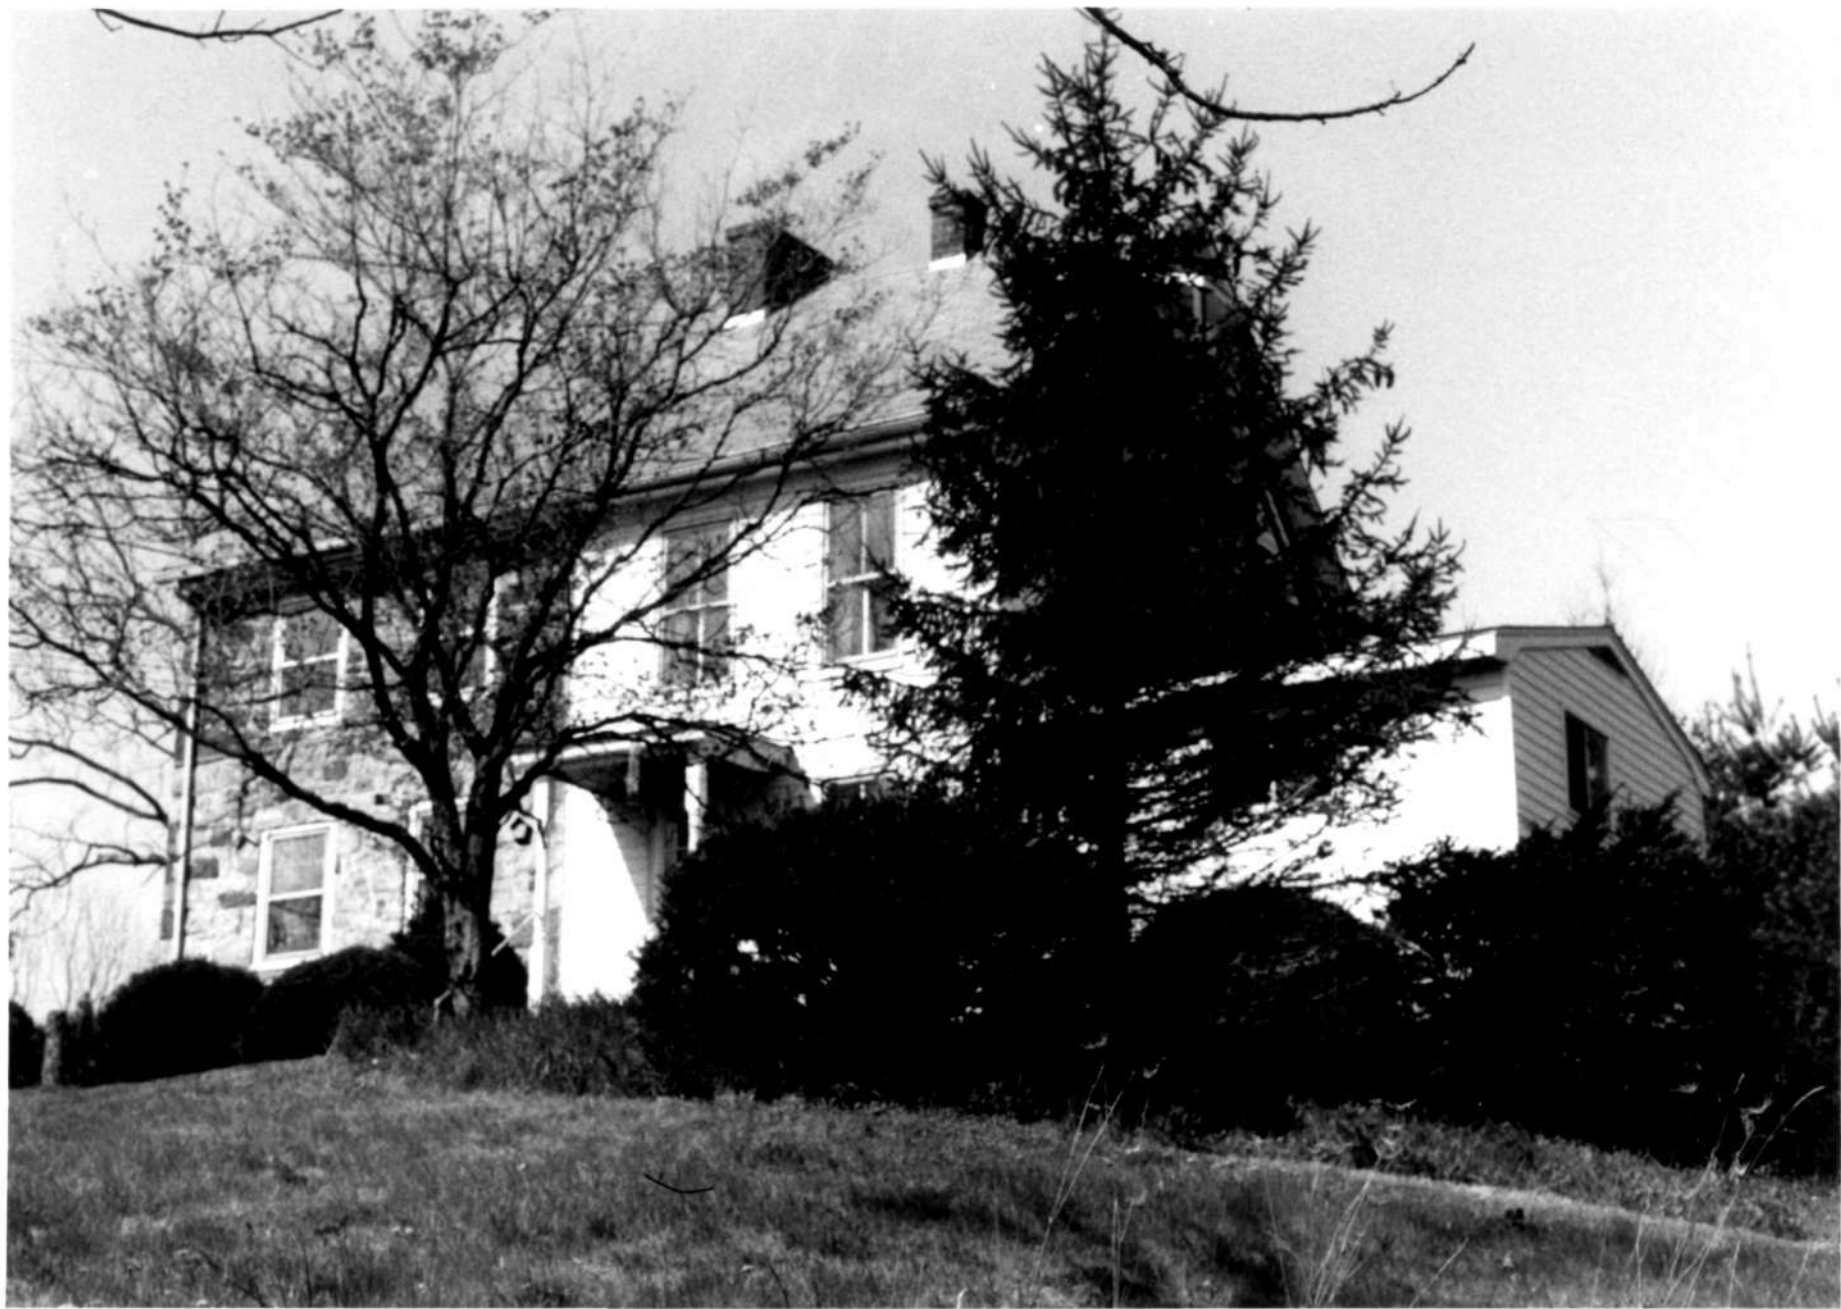
Hd-150  
The LORENZ HOUSE  
EAST  
CB THOMPSON, ACP  
APRIL, 1979

The Lorenz House faces east on the west side of Landing Road, just south of the east entrance to Rockburn Branch Park, once a part of the Lorenz House property.

- 1) The early nineteenth century structure is a two bay wide, one room deep, two story high, gabled roof (running north-south) fieldstone house, resting on a stone foundation, with wide brick chimney centered into its north wall. It features stone quoining and flat stone lintels with primitive keystones. A rectangular, one light entrance door is centered into its south wall, with two tall, rectangular, attic windows above. The east elevation holds two first and second floor rectangular, double-hung windows, holding six-over-one lights. The west elevation is similarly treated but has no first floor window in its north bay.

- 2) In 1907 a two bay wide, two room deep, two story high, gabled roof (running north-south) frame addition, resting on a stone foundation, and holding a square brick central chimney was constructed along the north wall of the original stone dwelling house. It features a rectangular, cross paneled east entrance door placed in the south bay and fronted by a flat roofed stoop, composed of four poured in place concrete steps and landing. The flat roof is supported by two curvilinear posts. This stoop, constructed by Mr. Lorenz replaces a one story high open porch, which ran along this entire elevation. A rectangular, double-hung window, holding two-over-two lights rests in the north bay of this wall. Above rest two second floor, vertically aligned windows.
